Case Study

Performance comparison of BOR-1Cr borided tubing versus conventional 1Cr L80 tubing for wear, erosion and corrosion resistance operating together in a rod pumped oil well

Comparison of EMI scanning results to 24 arm caliper measurements on borided tubing

Craig Zimmerman
Director – Technical
3/14/2022

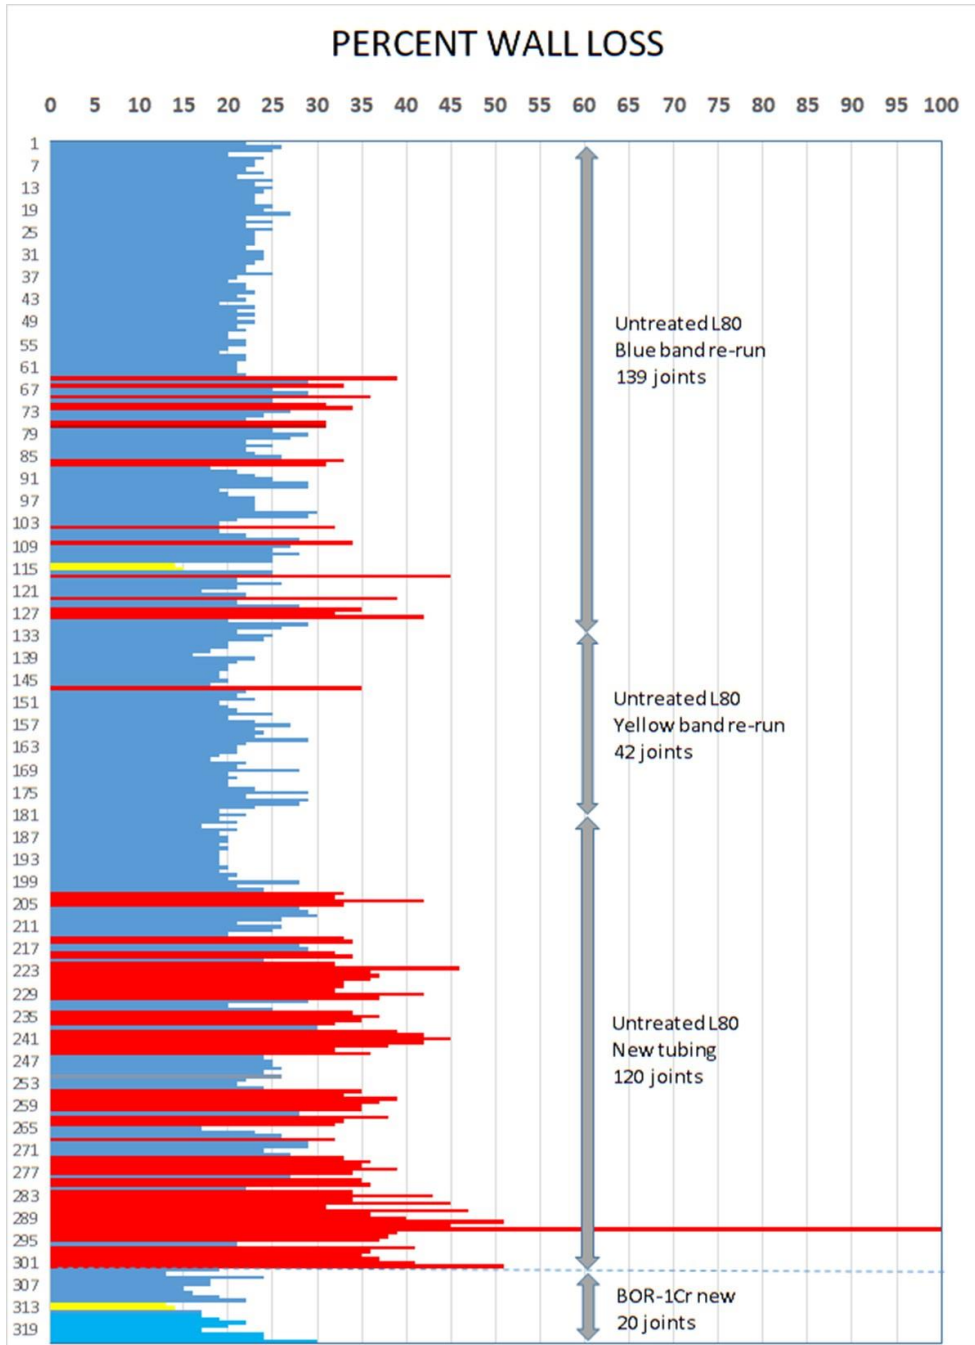
It was observed that the hole in tubing (HIT) failure had occurred in Joint #292. This was a conventional L80 tube that was sitting 10 joints above where the borided section of tubing had stopped.

All twenty of the borided BOR-1Cr tubes were measured to be either blue band (16-30% wall loss) or yellow band (0-15% wall loss). The average wall loss experienced by the entire group of twenty borided BOR-1Cr tubes was 18%.

In comparison, the next twenty untreated conventional 1Cr L80 tubes sitting above the borided section were all measured as red band (greater than 30% wall loss) except for one tube. The average wall loss experienced by the entire group of twenty untreated conventional tubes was 40%.

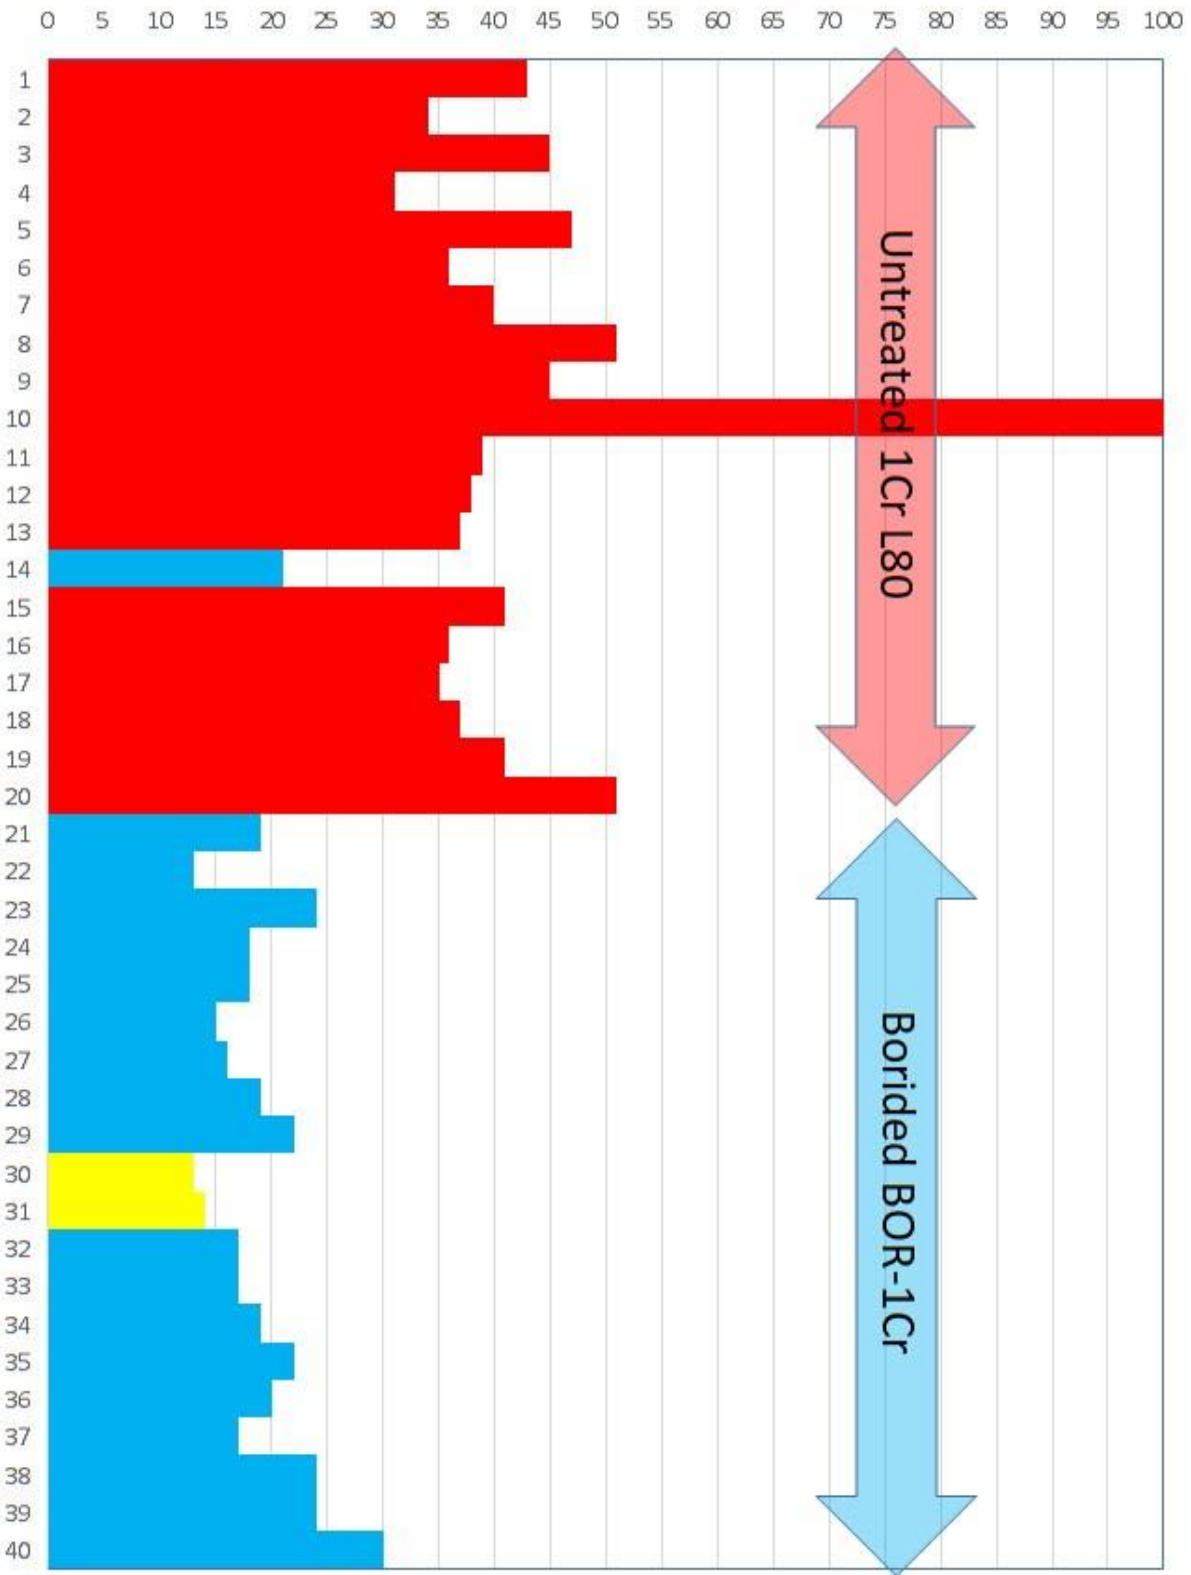
BOTTOM 40 JOINTS - % WALL LOSS BY JOINT LOCATION

This is an excellent demonstration of how well borided BOR-1Cr tubing performs compared to untreated tubing. The BOR-1Cr tubing outperformed the untreated tubing where the average wall loss in the borided tubing was less than half of the wall loss observed in the untreated tubing.

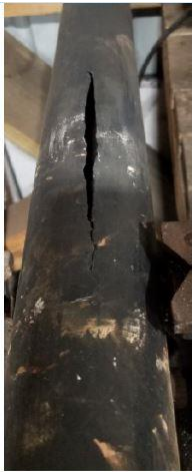
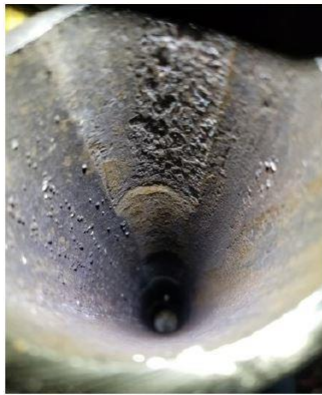
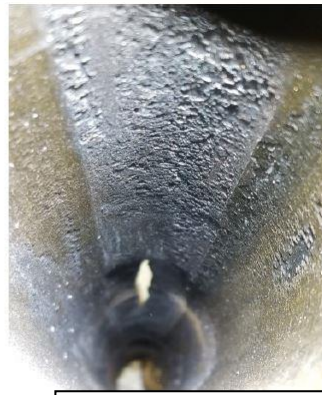
Jt #292: Split Jt. UT 0.068

Photographs and borescope video of both the untreated conventional tubing and the borided BOR-1Cr tubing were recorded to document the conditions of wall loss inside of the tubing. In the conventional tubing, rod wear accelerated corrosion was observed along with corrosion pitting. The joint #292 that failed had a severe wear groove from sucker rod wear that led to the wall thinning to the point where it burst open and ruptured due to internal pressure.

Untreated Joint 292 failed due to sucker rod wear that thinned the wall

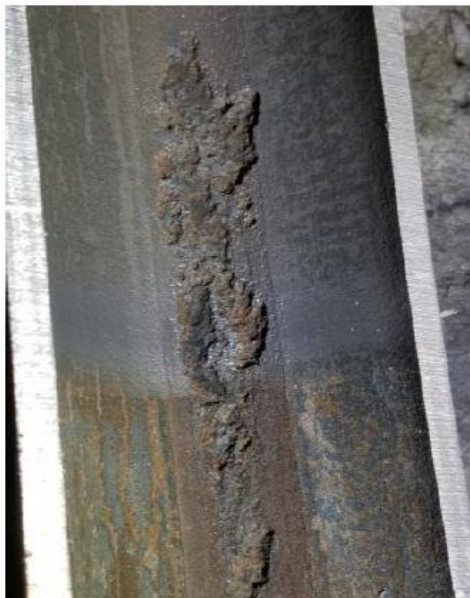
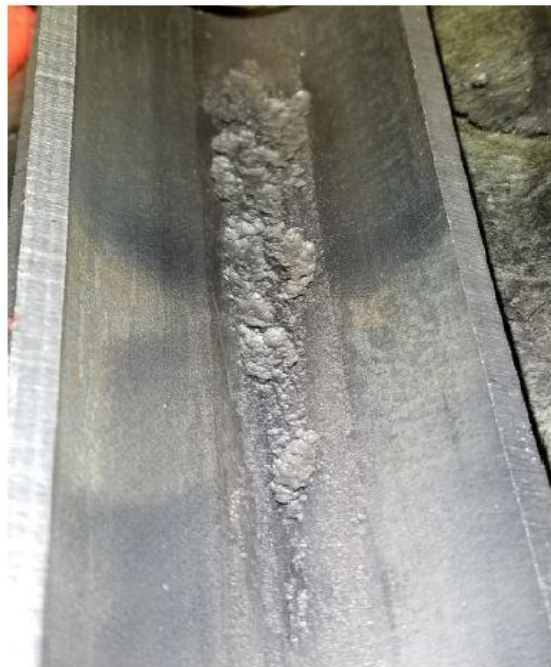
Untreated Joint 278 exhibiting some severe corrosion pitting

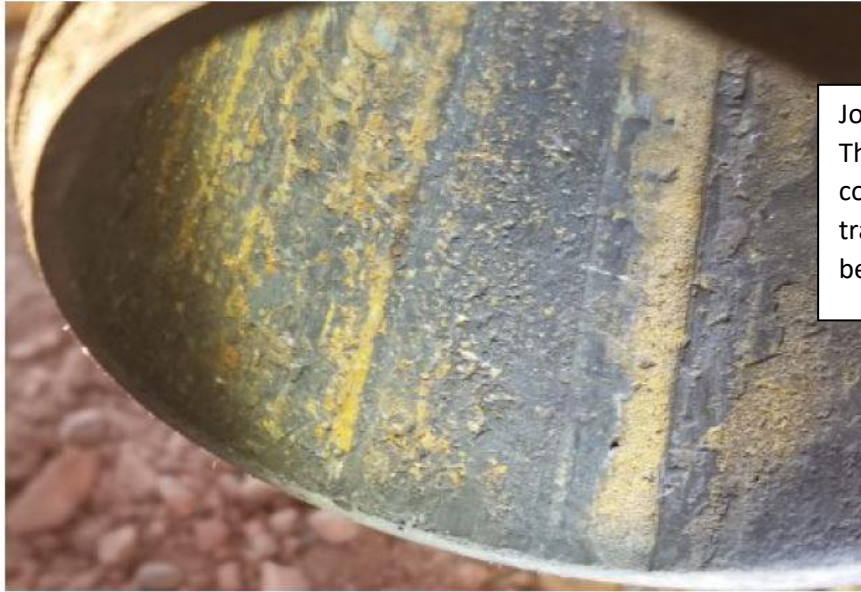
Jt #301: Wear

Joint 301 shows sucker rod wear. This is the bottom joint of untreated conventional L80 tubing before transitioning into the borided tubes below it

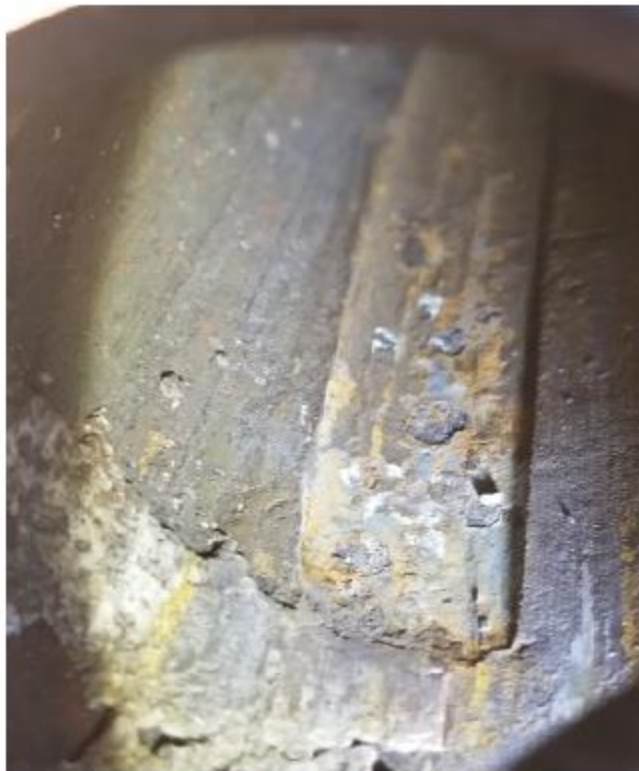
Jt #295: Wear / scale

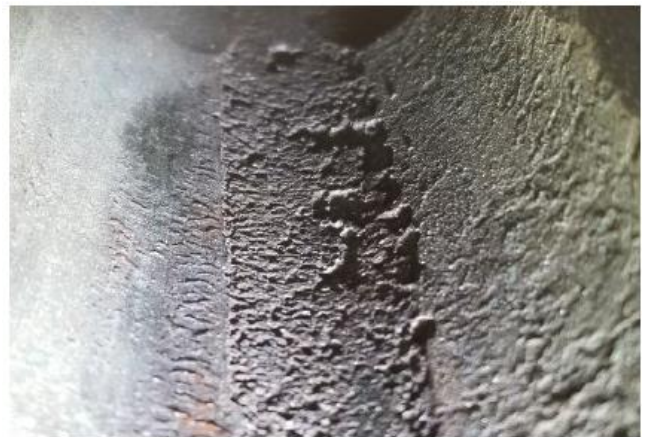
Jt #258: Pitting in wear

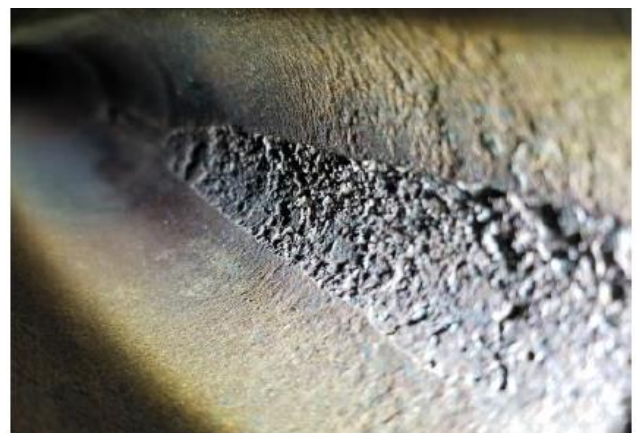
Jt #261: Pitting in wear

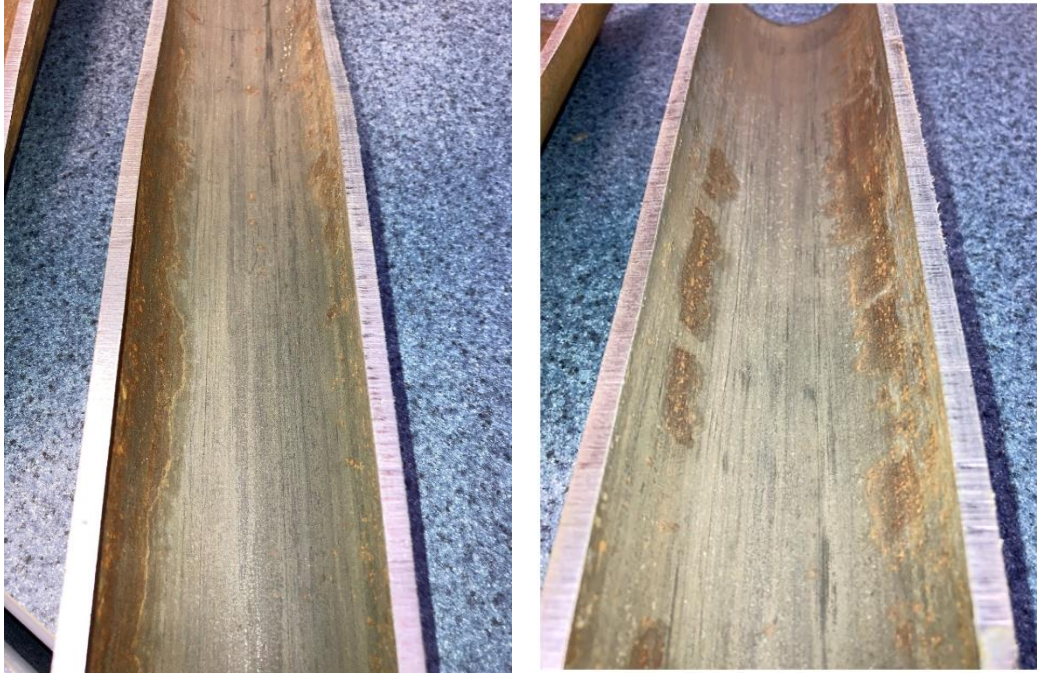
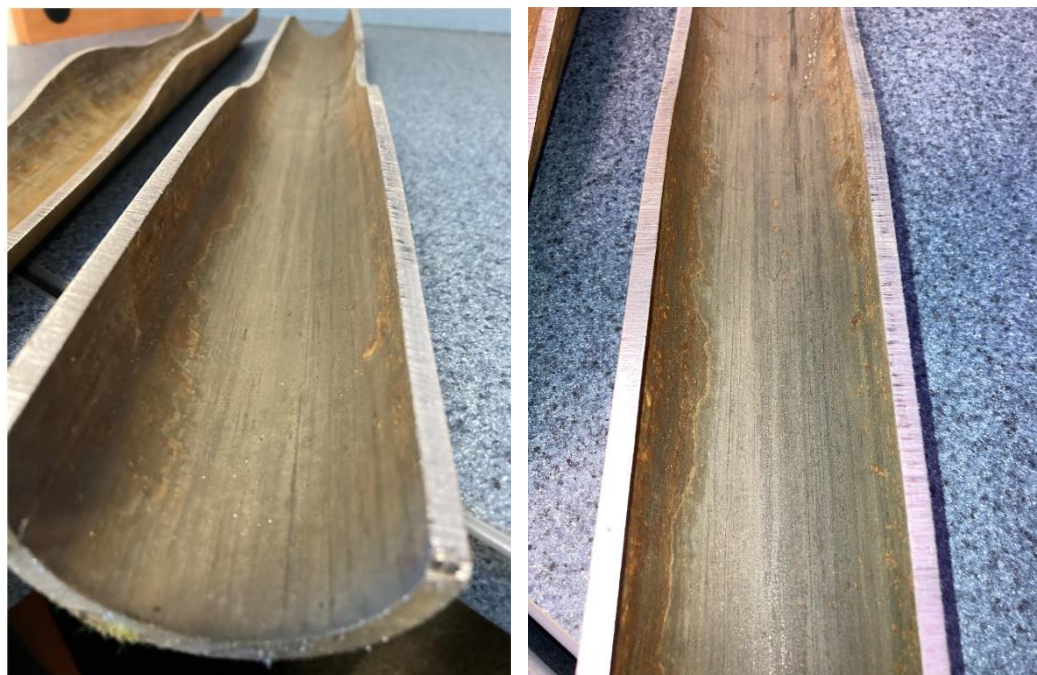
Borided BOR-1Cr tubing after use (Joints 320, 321, 322, 323)

The borided tubing was also inspected with a borescope. Several joints were also sectioned and cut open to get a better look at the interior surface. The borided tubing all appeared to have only minor wear and corrosion pitting present compared to the untreated tubing. Several photographs of the borided tubing is shown below.

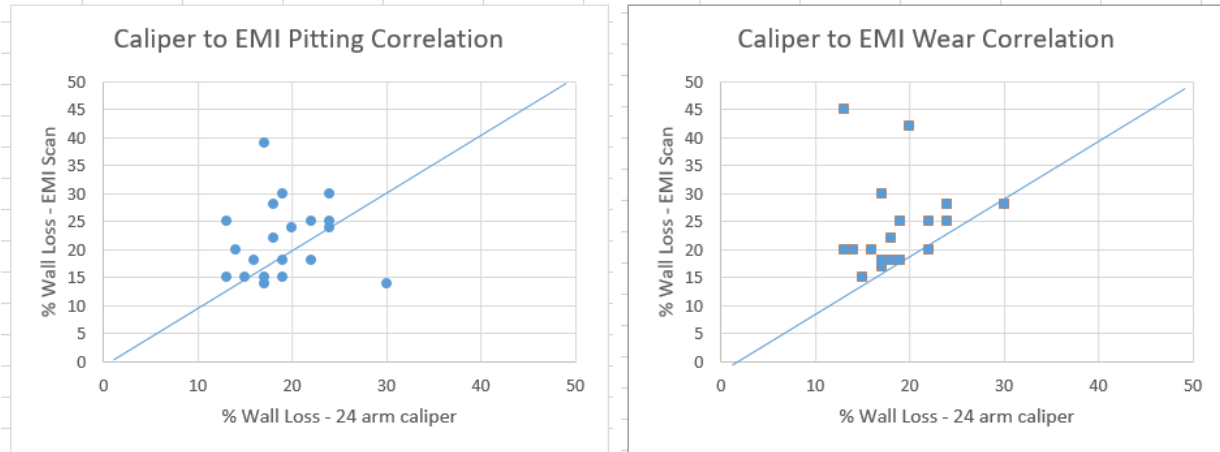
Correlation of 24-arm caliper measurements to EMI scan measurements

Close correlation between these two methods would produce a chart where all points lie on or close to the diagonal line where both methods would be producing identical results. Good correlation was not observed as caliper to EMI pitting data only had a correlation coefficient of 0.07 and caliper to EMI split data only had a correlation coefficient of 0.13. The results indicate that neither the EMI pitting or EMI split results correlate well to the results as measured by 24-arm caliper tool. It can be observed in the charts above that the EMI scan results were more often showing higher levels of wall loss compared to the 24-arm caliper tool. As stated earlier, the 24 arm caliper tool is likely to produce a more accurate result based on it being a mechanical measurement method that would not be affected by an iron boride subsurface layer being present in the tubing. This layer does affect the electrical and magnetic properties of the steel and is believed to affect EMI readings and produce more inaccurate results.
