Case Study

Performance comparison of BOR-1Cr borided tubing versus conventional 1Cr L80 tubing for wear, erosion and corrosion resistance operating together in a rod pumped oil well

Comparison of EMI scanning results to 24 arm caliper measurements on borided tubing

Craig Zimmerman
Director – Technical
3/14/2022

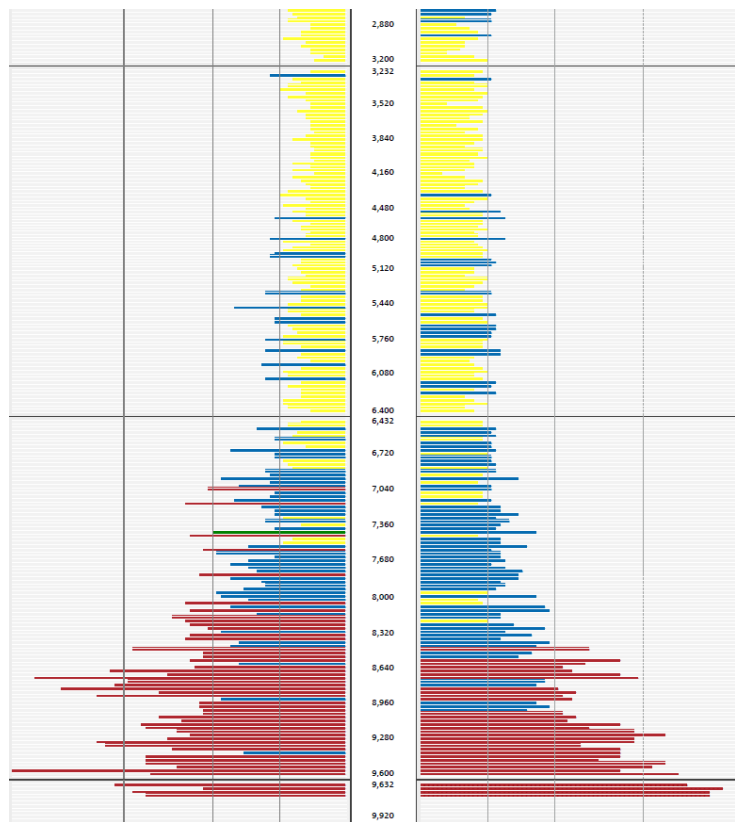
Example of Tubing EMI Scan results

A typical EMI scan shown below demonstrates that the most severe areas for wall thickness loss in tubing strings is at the deepest depths closest to the pump. These results do not show any borided tubing as EMI scanning has been deemed to not be accurate for borided tubing as the boride layer can affect the electrical and magnetic properties of the steel and give inaccurate results when EMI scanned.

Shorter yellow bars indicate less pitting and wear with little wall loss

Longer red bars indicate more pitting and wear with greater wall loss

Top of graph is yellow band tubes near surface while bottom of graph is red band tubing next to pump at bottom of well

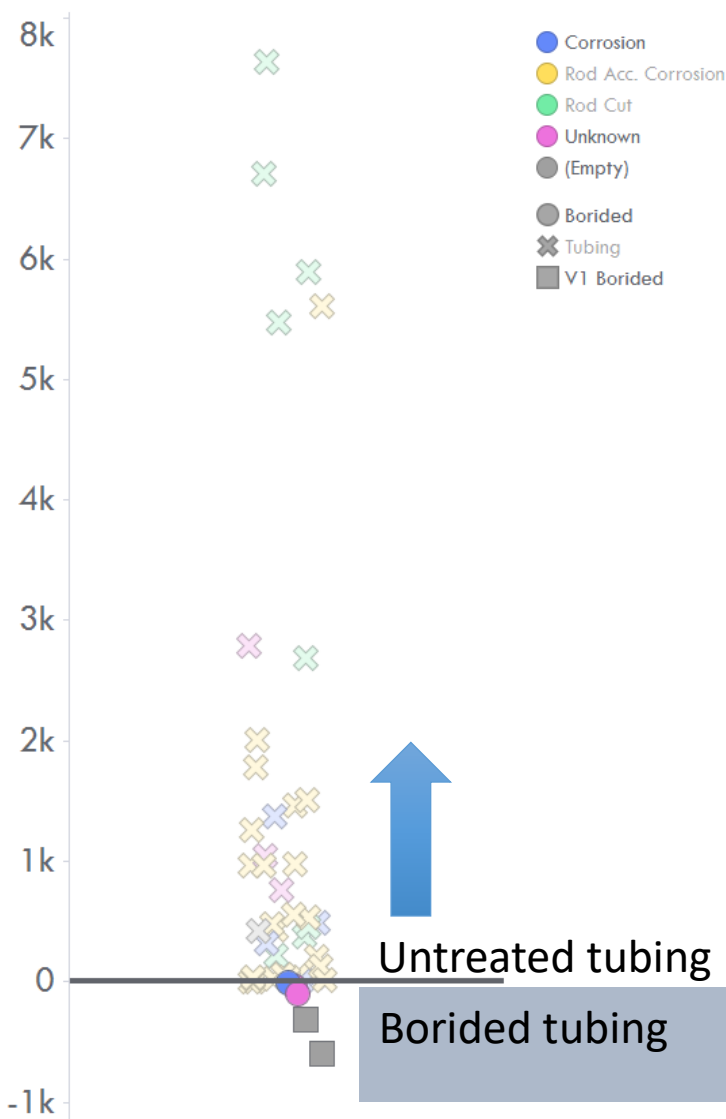
This same major oil producer has also started tracking what depth any hole in tubing failures have been occurring with relation to the transition between borided tubing and conventional tubing. A review of short run tubing failures (<450 days) from 2019 to 2011 is displayed in the graph below. The depth of zero on the graph below denotes the location of the transition

between borided tubing and conventional tubing. Any failures above zero depth have occurred in untreated conventional tubing. Any failures below zero depth have occurred in the borided tubing. The graph below is a plot of all locations of failure with respect to the transition point.

It has been observed that only 2% of their current hole in tubing failures are occurring in the borided tubes despite the fact that the borided tubes are placed in the most severe locations for these failures.

This is additional evidence that borided tubing definitely does mitigate hole in tubing failures from occurring. One can observe that the majority of hole in tubing failures are continuing to occur at the deepest depths in the regular L80 tubing sitting just above the borided tubing. This is the reason that several oil

producers have recently decided to place additional borided joints in each well to extend their wear and corrosion protection across more footage where these failures continue to persist.

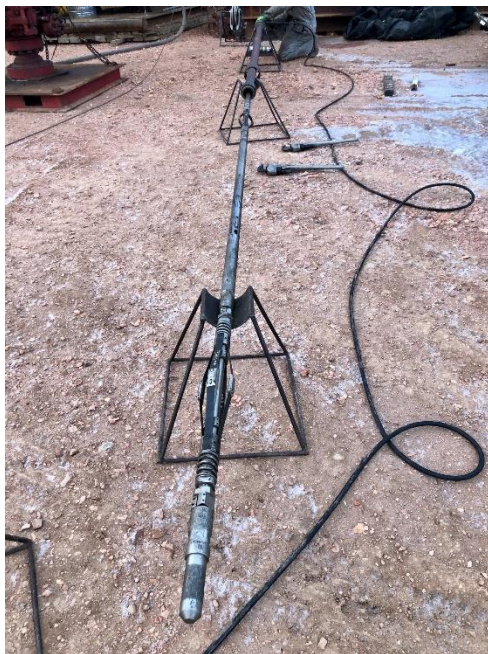
24 arm caliper tool

Photos below show the 24-arm caliper tool that was used to measure the tubing. This tool was lowered by wireline to a 10,000 foot depth at the bottom of the tubing string. The temperature measured at 9,500 ft depth was 229F. The caliper arms were then extended and the tool was run upwards from the bottom of the hole at 80 feet per minute as it measured the wall thickness at 24 equidistant points around the tubing bore circumference until it reached the top joint in the well. All datapoints were recorded as the caliper traversed up the well.

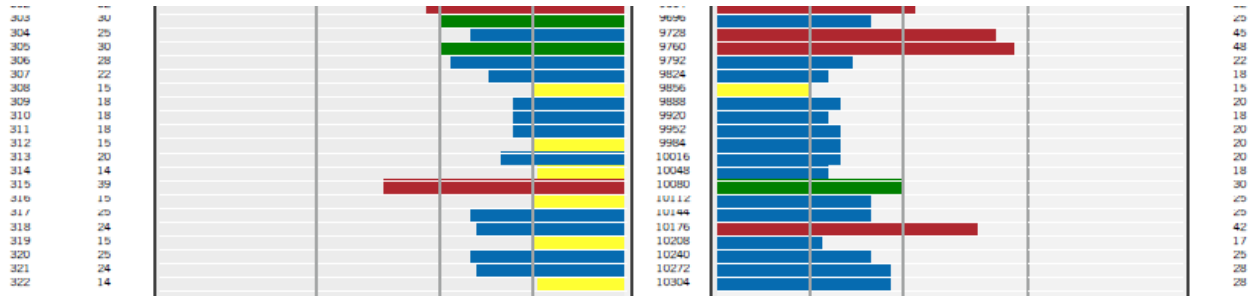
After the caliper run had been performed, the tubing was pulled from the well and each tube was EMI scanned during the pull to sort and separate yellow, blue and red band tubing. Because EMI scanning has not been well accepted as a good measurement technique for borided tubing, we wanted to compare the EMI results to the 24 arm caliper measurements that were taken a day earlier on the same twenty borided tubes.

The EMI scanning results are displayed below. The EMI scan yields two rating numbers for each tube. The bars on the left represent “Pitting” while the bars on the right represent “Wear/Split”.
